RAYMARINE SAFETY RECALL

SPX5 SPORT DRIVE PILOT and control head E12206

SPX5 SPORT DRIVE PILOT pilot only E12132

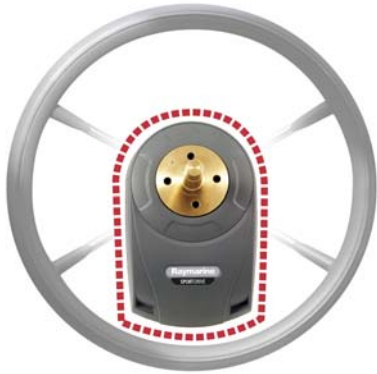
As customer safety is of paramount importance to Raymarine, we have decided to initiate a voluntary recall of this product. We have identified a potential component problem with the SPX5 Sport Drive Pilot product which we have sold between February and July 2009.

As a result the mechanical clutch assembly may fail, causing the steering of the vessel to lock in one direction, with a possible risk to the safety of the vessel and crew.

Customers must stop using the products immediately and arrange de-installation and return to the retailer/dealer from whom it was purchased.

The retailer/dealer will arrange for a replacement or, if preferred, a refund.
